USAID/Haiti Internal Evaluation of the Community Reconstruction for Economic and Environmental Resiliency Program Final Report December 2003

A. Irrigation System Upgrades—Orangers Irrigation System

B. Road Rehabilitation—Carrefour Cirouelle-Macary-Berry Road

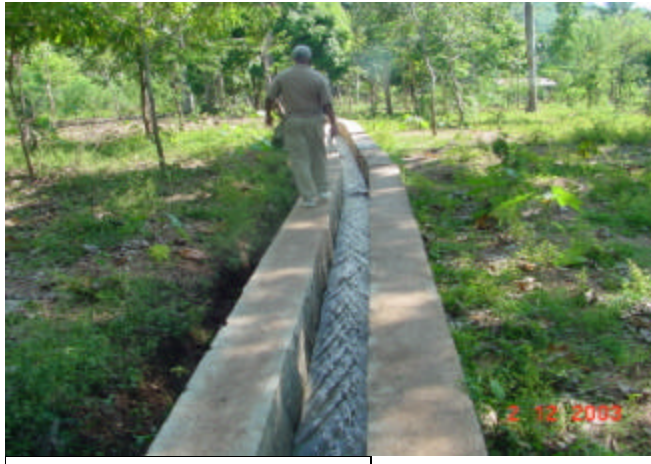
Status of Work Performed Under CREER. Work began in September 2003 and is continuing. Canal masonry is 100% completed and appears to be structurally satisfactory (Photo 2). Additional work remains to be done on the gates and overpasses (Photo 3). Frantz Joseph commented that the gates for the system have been ordered and will be installed upon delivery in December.² At the time of the evaluation, two overpasses had been constructed and it is anticipated that the remaining two will be built by the end of

Photo 2: Example of canal masonry work at the Orangers irrigation

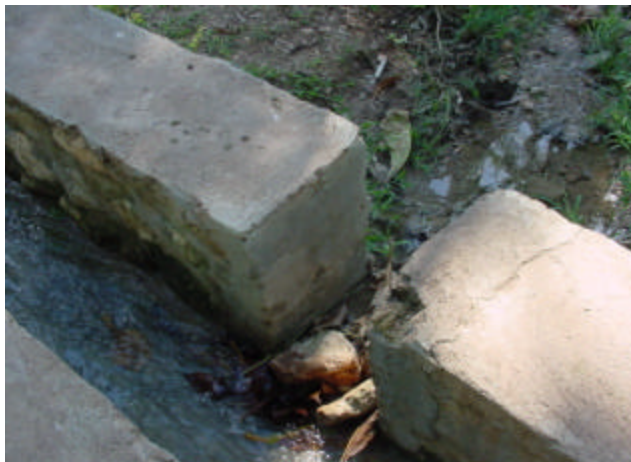
Photo 3: Example site where gate will be installed in December 2003.

² The gates were not installed at the time of the evaluation visit because the users had asked the contractor to instead extend the secondary canals in order to serve more farmers. The missing gates were later installed at the contractor's expense.

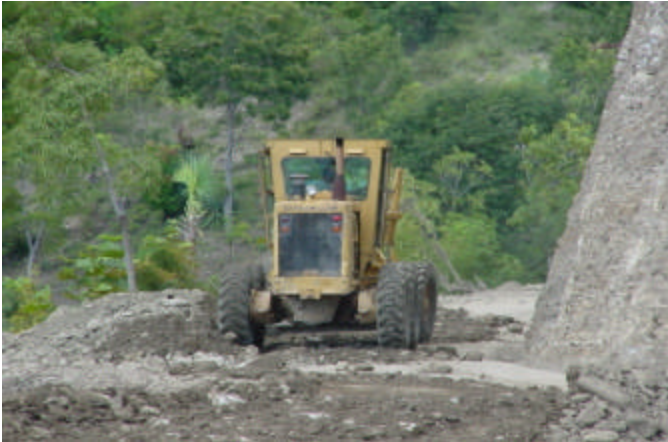
Key Findings. The subject road is located in mountainous landscape with extremely steep slopes that requires sophisticated drainage measures for protection. The evaluation team had a positive impression of the quality of the road rehabilitation but also observed that: (1) additional transversal culverts might improve drainage for the road and reduce the velocity of the water³; and (2) the mostly clay cover material used on kilometers 0-9 left the surface slippery and made traction difficult⁴.

Photo 4: Road expansion work taking place. Photo shows vertical cuts into cliff side at right.

³ PADF commented that standards for secondary mountain roads using average rainfall rates were used for the project. However, overhead rate adjustments in the amount of \$22,000 will enable PADF to increase the number of drains installed on the road.

⁴ This problem had been noted by PADF before the time of the evaluation and GNP Ingenierie is currently in the process of re-applying a second material that is sand-based to improve traction.

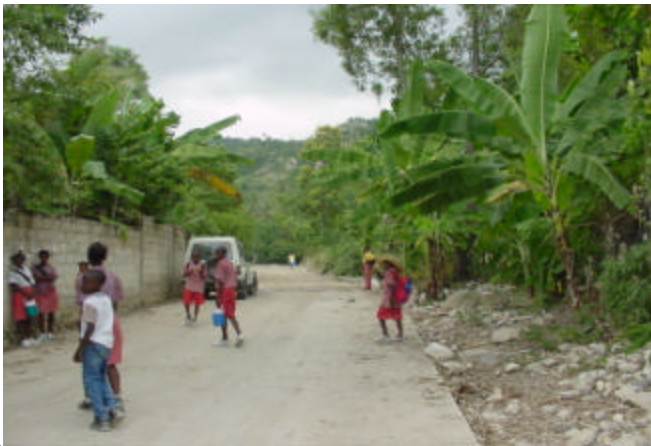
The rehabilitated road appeared to be well-used with abundant foot and vehicle traffic viewed in both directions (Photo 5 & 6). In addition, the evaluation team observed the selling of products grown in the Berry region in Macary; thus, the road seems to provide market access for farmer extension activities (Photo 7).

Photo 5: Vehicle and pedestrian traffic using the Carrefour Ciroulle-Macary-Berry (CCMB) Road.

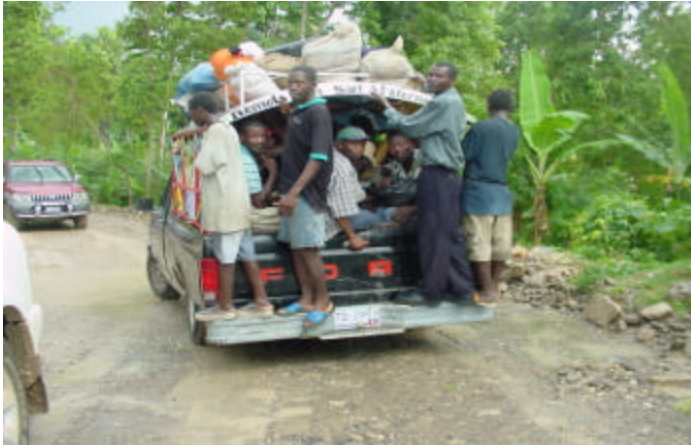
Photo 6: Vehicle traffic on the CCMB Road

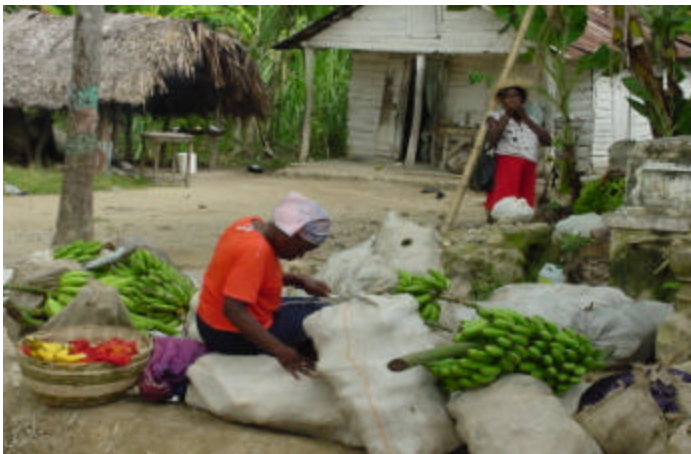
Photo 7: Merchant from Berry selling produce in Macary.

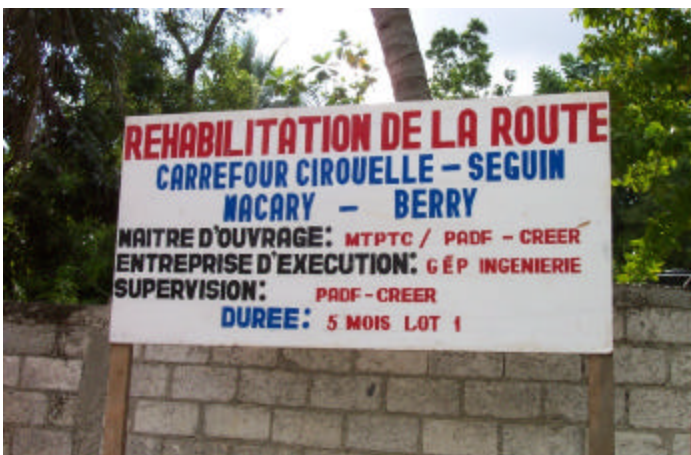
The team also noted the absence of reference to USG funding on CCMB Road project identification signs (Photo 8).⁵

Photo 8: CMB Road project identification sign

⁵ PADF immediately corrected this situation after the evaluation and added appropriate USDA citation to project signs (Photos 9 and 10).

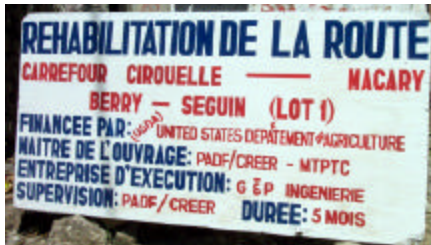
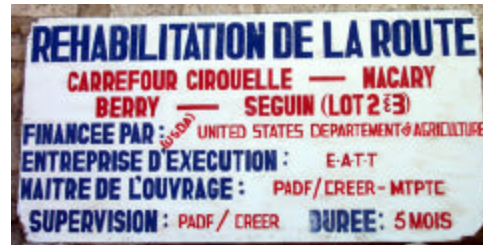
Photos 9 and 10. Signs at the CCMB project site indicating USDA as the funding source.

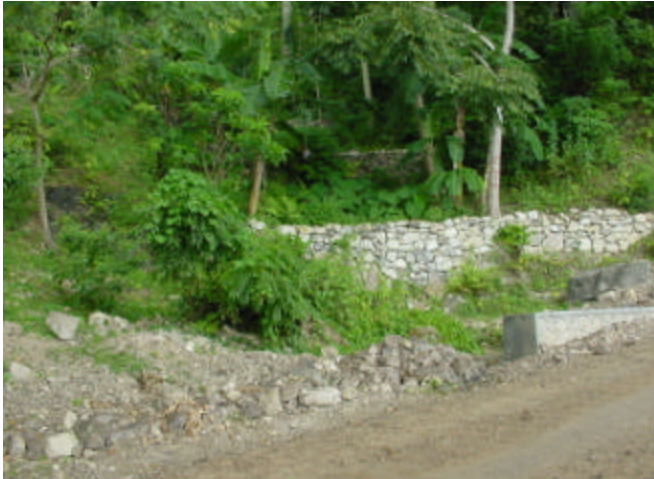
Key Findings. Although the evaluation team was limited to making observations from the road, all ravine protection devices appeared to be functional and well-constructed (Photo 9). At the time of the evaluation, insufficient time had passed from project completion to assess the project's impact on low-lying areas. However, the team noted that sufficient soil retention was occurring on the tiers behind the barriers to enable the growth of plantain and other vegetation, which indicates that the structures were functioning effectively.

Photo 9: Example of Ravine protection devices constructed along the CCMB Road.

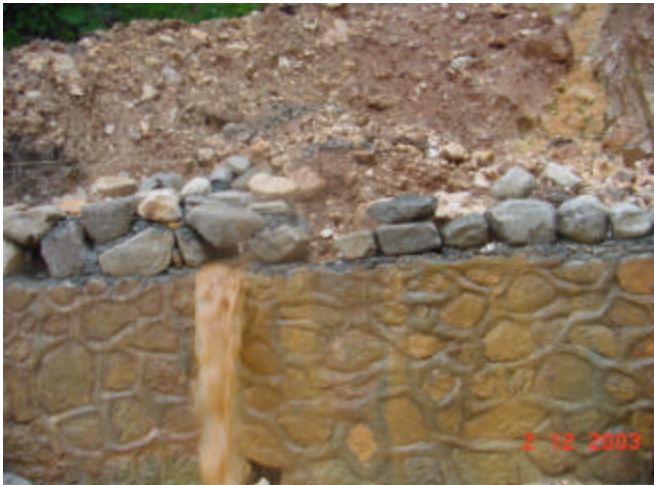
Photo 10: Operation of protection devices during a rainstorm.

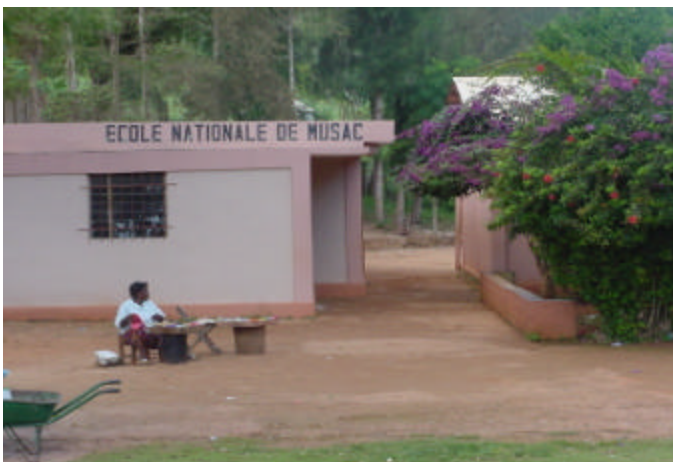
Status of Work Performed Under CREER. The work at the Ecoles Nationale de Evelina Levy/Leonie Jastram began in June 2003 and was completed in September 2003. At the time of the evaluation, upgrades to the Ecole Nationale de Musac were mostly completed. The painting of the facilities at the Ecole Nationale de Musac (Photo 14) and attachment of hurricane clips to the roof was completed in August 2003. The door was purchased and delivered but was not installed by the subcontractor (Photo 15). In addition, the new rain gutters were partially installed.

Photo 14: View of freshly painted building at Ecole Nationale de Musac.

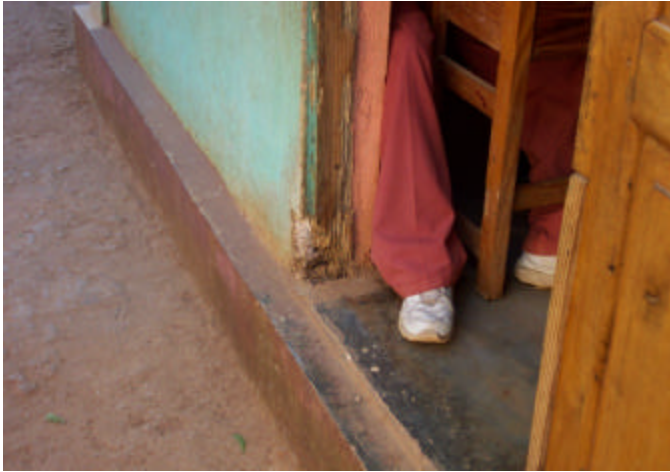
Photo 15: View of door frame at Ecole Nationale de Musac where new door will be installed.

Key Findings—Ecole Nationale de Musac. Although incomplete, the evaluation team found the work performed at the Ecole Nationale de Musac to be of good quality. One important note is that PADF had received a project completion notice from the subcontractor despite the project’s incomplete status.⁷

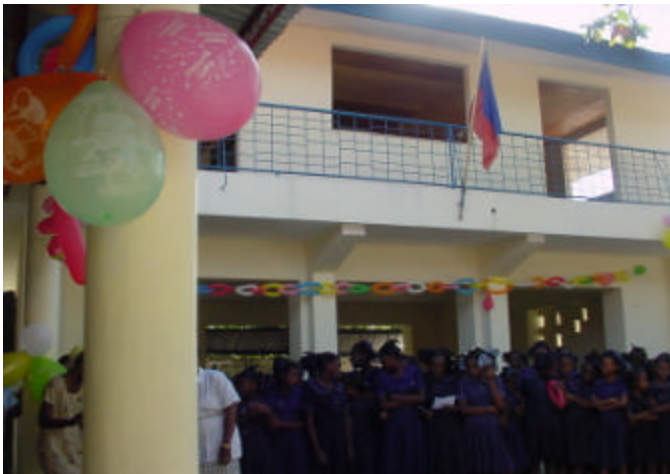
Key Findings—Ecoles Nationale de Evelina Levy/Leonie Jastram. The evaluation team found the school rehabilitation work performed under CREER to be well-designed and implemented (Photos 16 and 17). However, there was confusion among the beneficiaries as to the source of funding for the upgrades. A plaque outside the main doors of the facility attributed the funding for the work to Citigroup; there was no reference to the USG.⁶ However, PADF had placed a page on its website (www.padf.org) and distributed brochures about the CREER activity that cited USDA as its funding source.

Photo 16: View of roof upgrades and beneficiaries at Ecole Nationale de Evelina Levy.

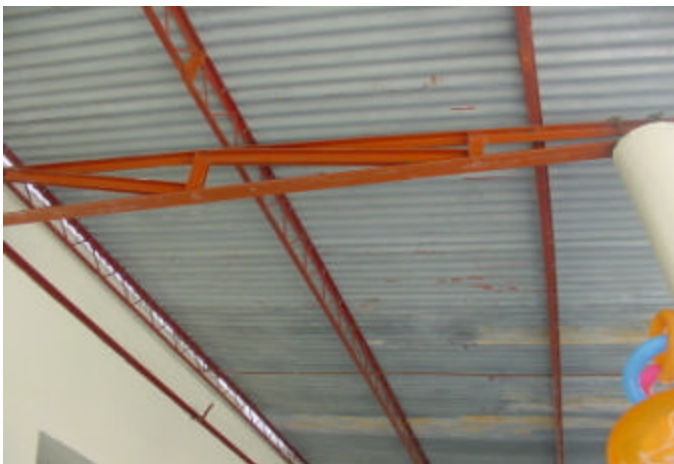
Photo 17: Close-up view of roof repairs at Ecole Nationale de Evelina Levy.

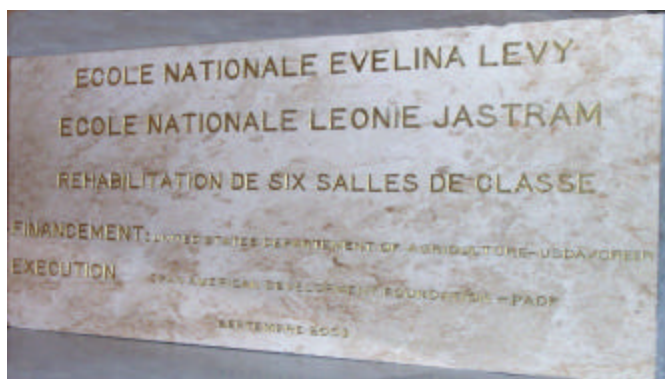
Photo 18: Plaque indicating USDA financing at Ecole Nationale de Evelina Levy.

⁶ PADF commented that the public inauguration of the Citibank project took place before CREER funds were used. An announcement was made during the inauguration that USDA/CREER funds would soon be invested in another section of the combined schools. A second plaque indicating the USG's role in the rehabilitation was immediately installed after the site visit (Photo 18).
